CALIFORNIA DIVISION OF MINES AND GEOLOGY

FAULT EVALUATION REPORT FER - 117

March 28, 1981

Greenville fault. (includes southeast end of Marsh Creek fault).

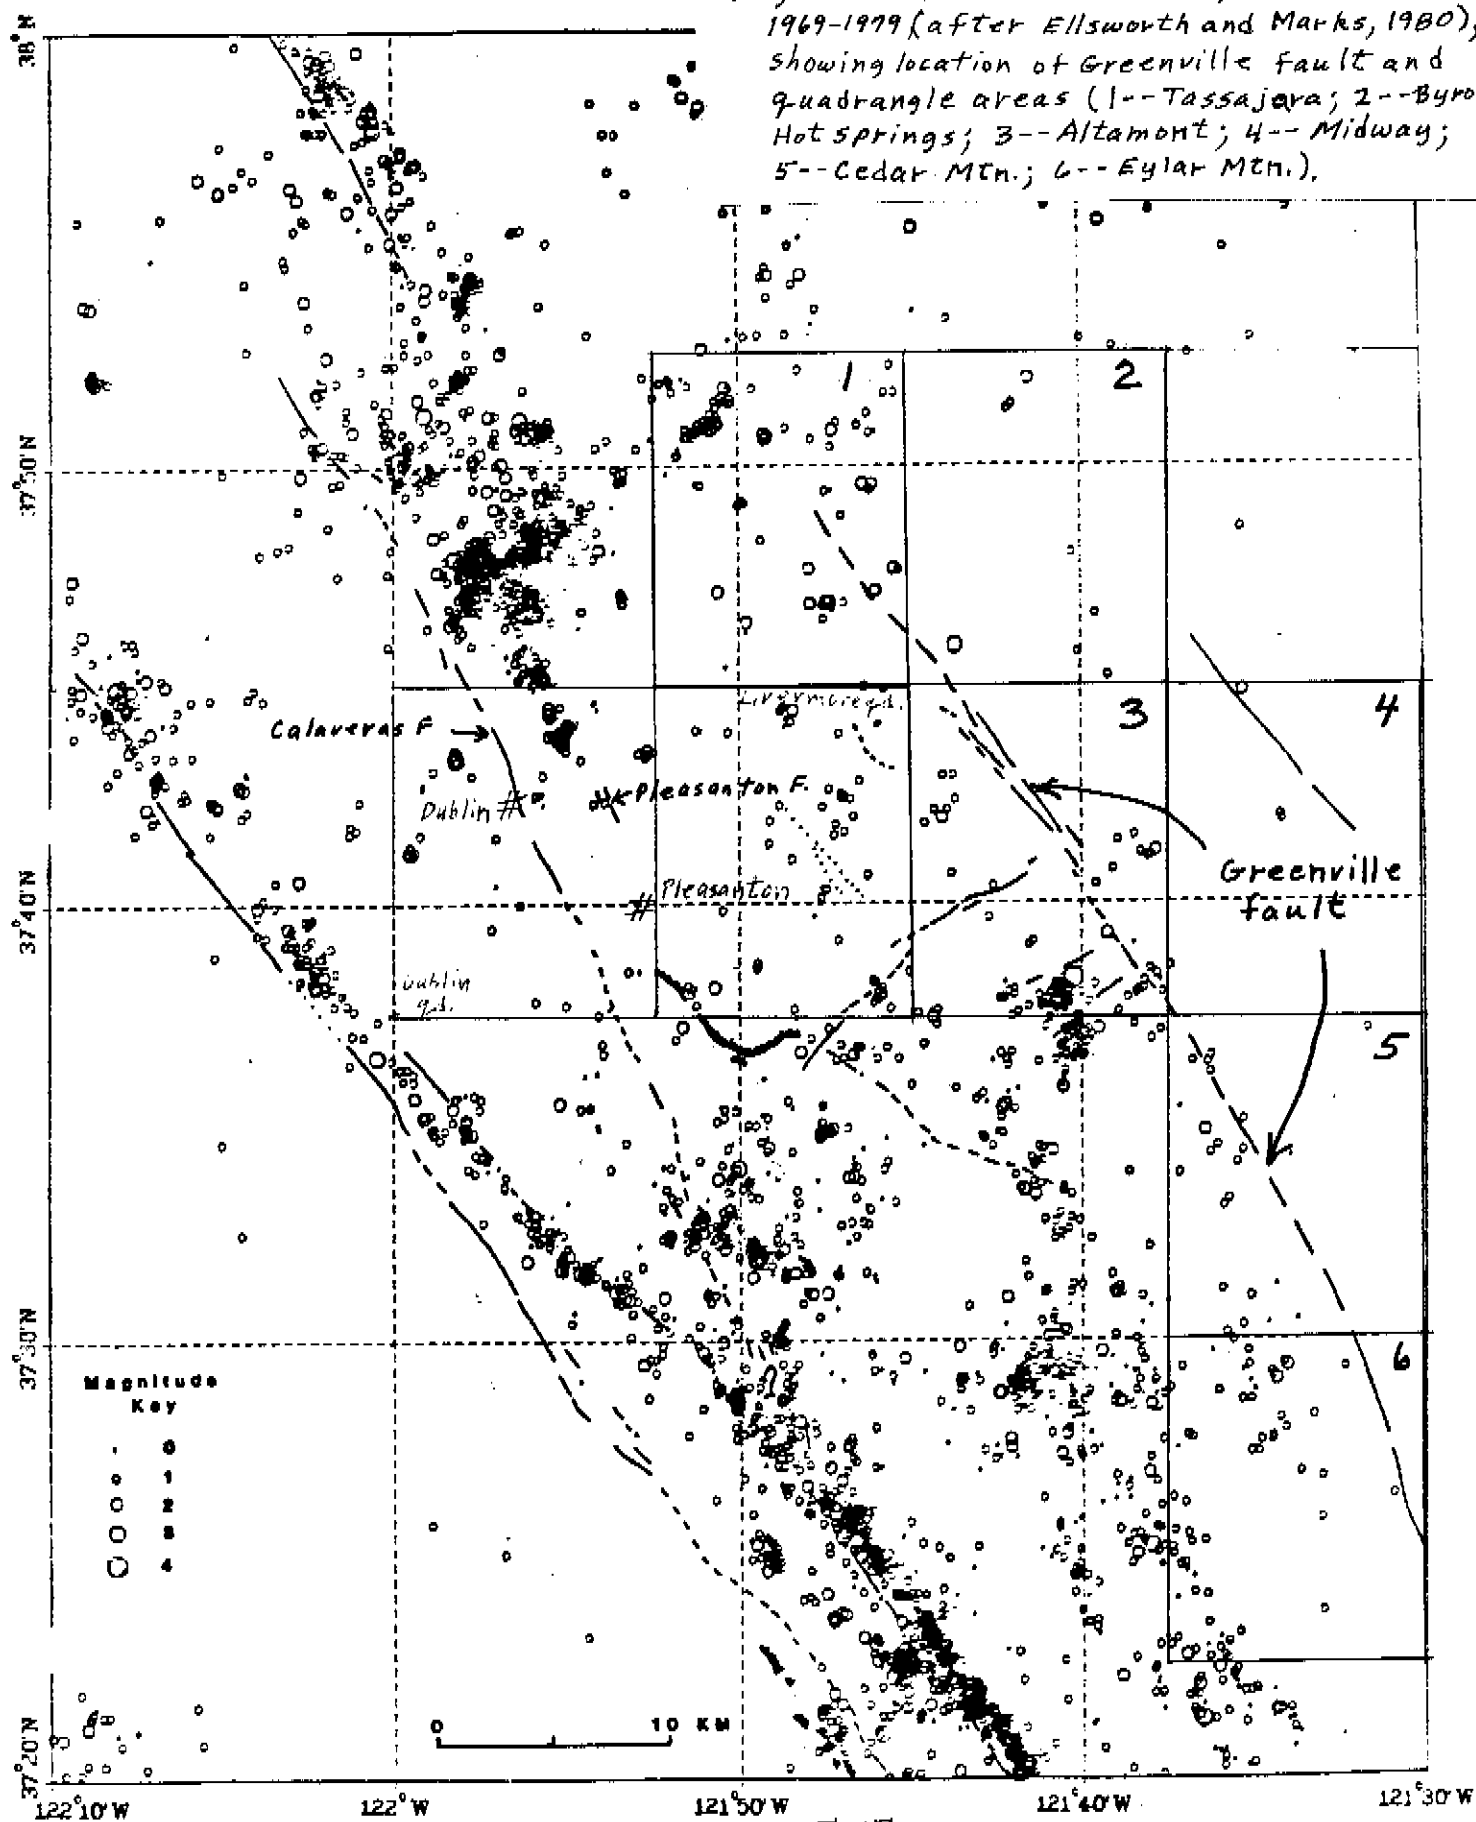
Figure 6 (FER-117). Earthquake epicenters 1969-1979 (after Ellsworth and Marks, 1980), showing location of Greenville fault and quadrangle areas (1--Tassajara; 2--Byron Hot Springs; 3--Altamont; 4--Midway; 5--Cedar Mtn.; 6--Eylar Mtn.).

The epicenters shown in Figure 6 would seem to suggest that the Greenville fault is seismically active in the Cedar Mtn and probably the Eylar Mtn quadrangles. However, this area is not well-covered by seismic stations.

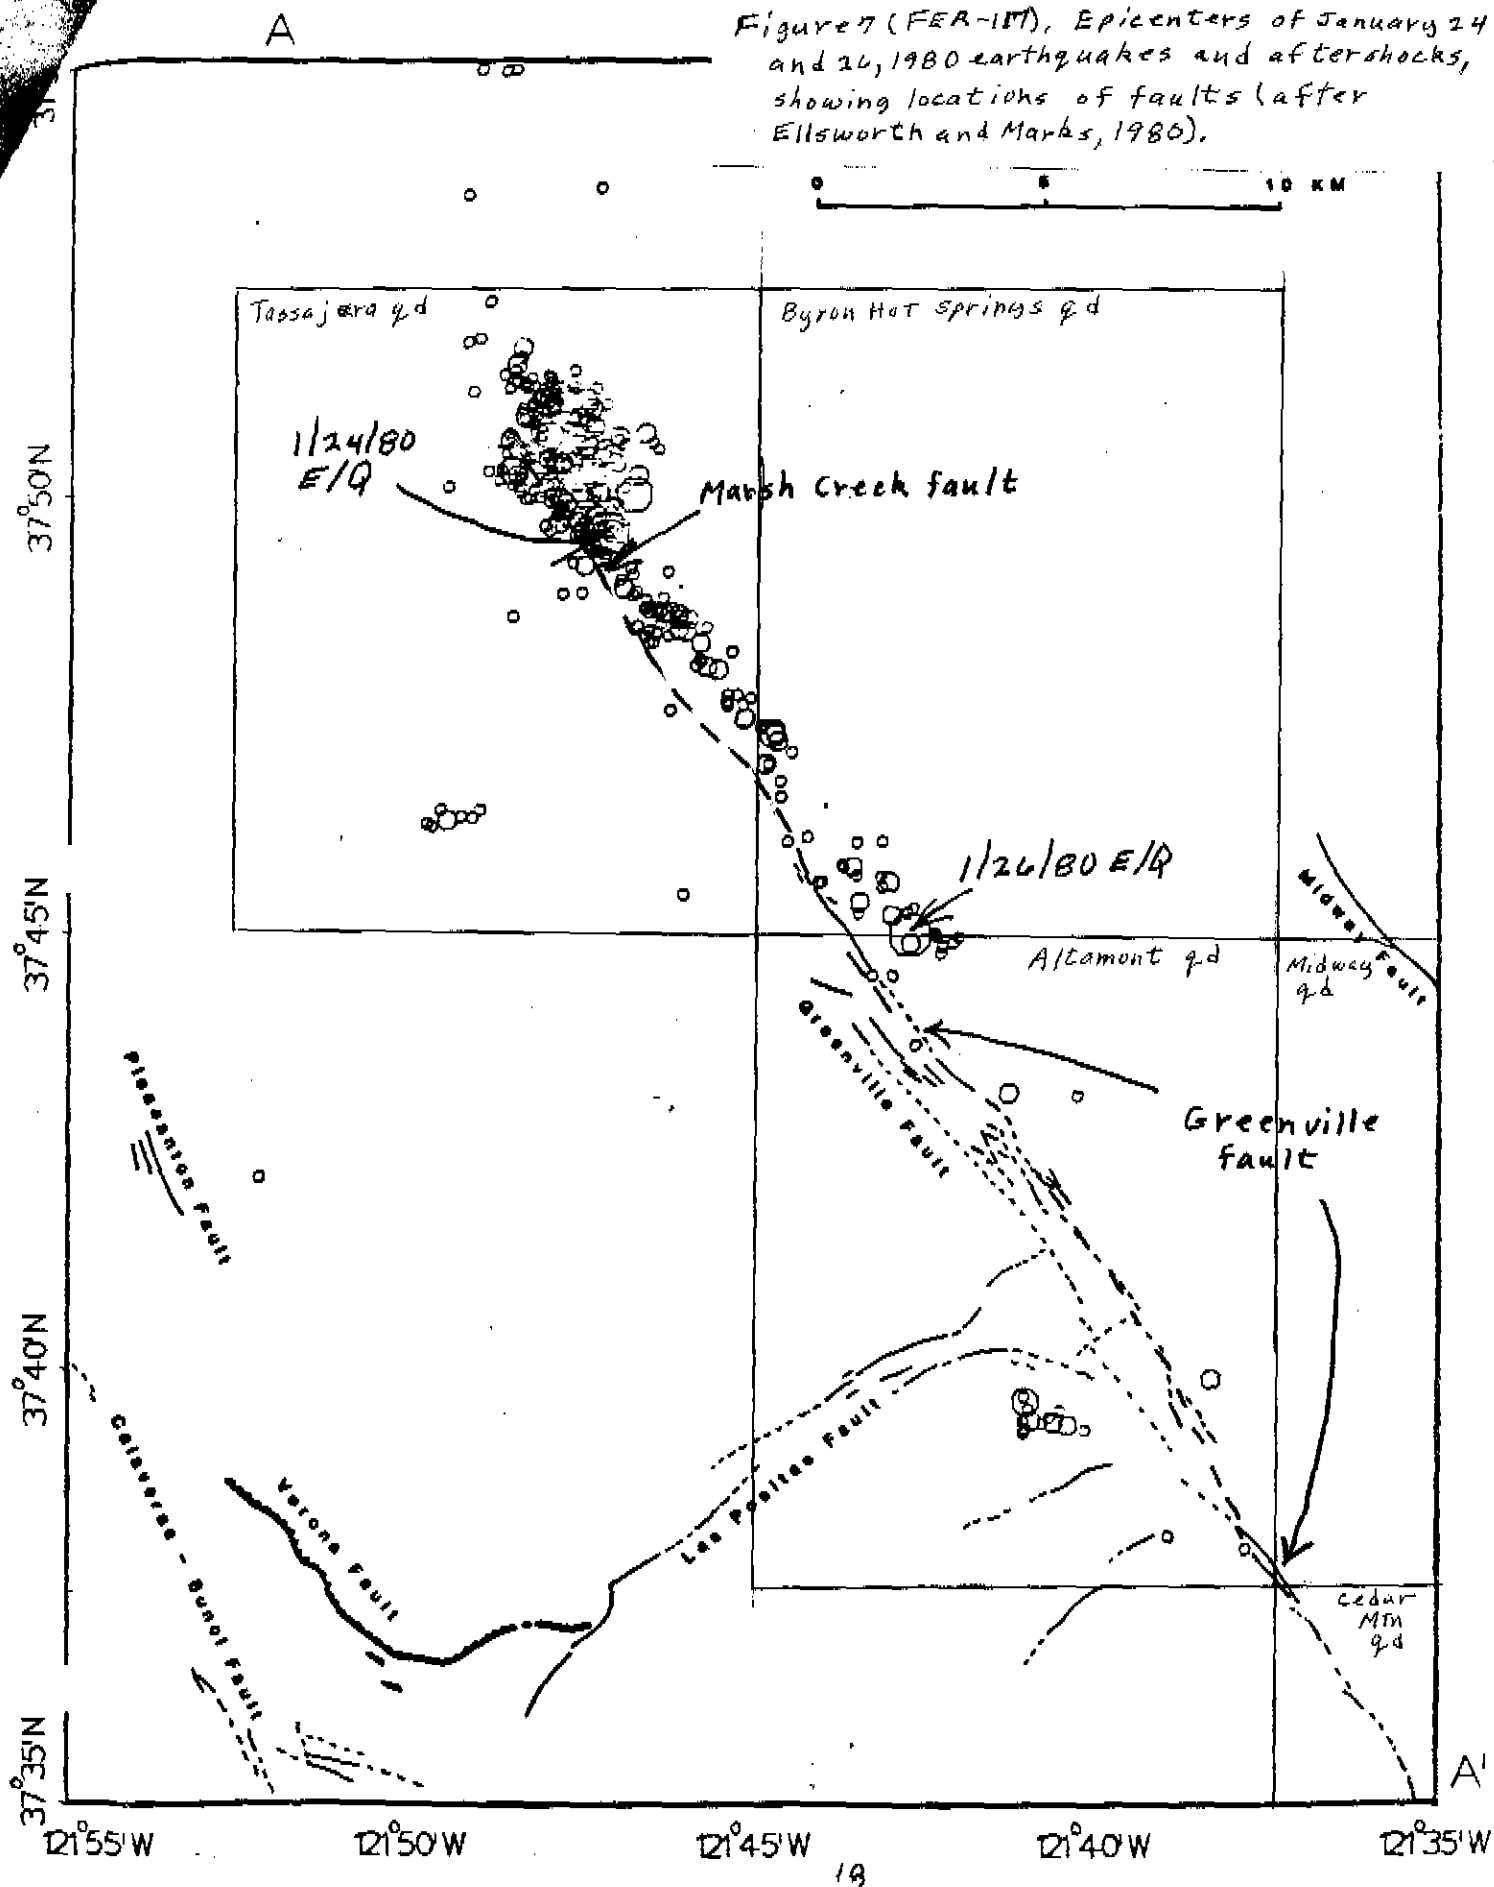
Figure 7 (FER-107), Epicenters of January 24 and 26, 1980 earthquakes and aftershocks, showing locations of faults (after Ellsworth and Marks, 1986).

The minor fault-rupture that occurred in association with the 1980 earthquakes extends discontinuously northwest from Highway I-580 almost to Contra Costa County (Fig. 4; App. A), partly as sudden rupture and partly as after-slip. Suprisingly, no ground rupture was found along the Marsh Creek fault segment, even though it coincides with the main earthquake of January 24 and lies along a well-defined zone of aftershocks (see item 7, below).

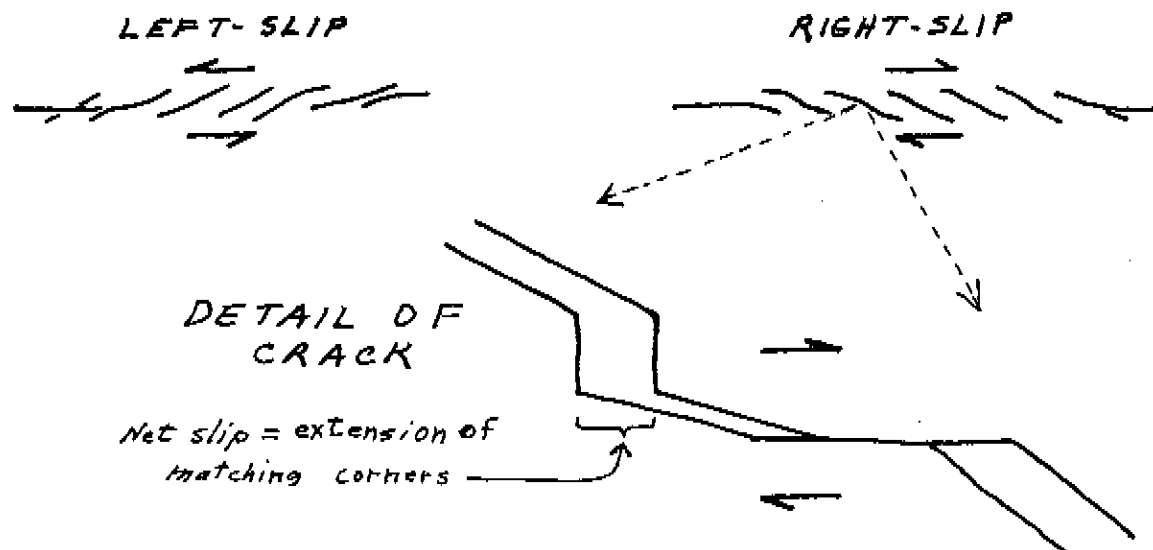
Figure 4. *En echelon fracture patterns diagnostic of right-lateral and left-lateral fault slip:*

Laughlin Road at foot of hills. Left-stepping en echelon (figure 4) cracks in asphalt pavement identify a segment of the Greenville fault that was active following the 5.5M Livermore Valley earthquake of January 24, 1980. These cracks coincide with a trace mapped by Huey (1948) and Herd (1977). The cracks were not noted 3 hours after the earthquake but appeared by January 25, when 2 mm of right-lateral slip was measured. This cracking preceded the 5.2M earthquake of January 26, which was centered near Frick Lake. Colored marks on pavement were painted by Woodward-Clyde Consultants to monitor afterslip. Re-observation of the cracks showed 5 mm of right-slip on January 30 and 7 mm on February 27, an additional 1-2 mm of slip was reported on April 3 (D. Schwartz, 4/4/80). Thus, most, if not all, of the slip has occurred as afterslip - either by creep or incrementally. The zone of cracks could be traced northwestward in the soil prior to the heavy rains of February. 1000 feet southeast of Stop 2 is a broad zone of N to N30°E - trending cracks in the pavement that suggest right-lateral slip of 1.7 cm and 0.3 cm vertical slip (east side down). Note the progressive right-lateral offset of the paint marks, demon-

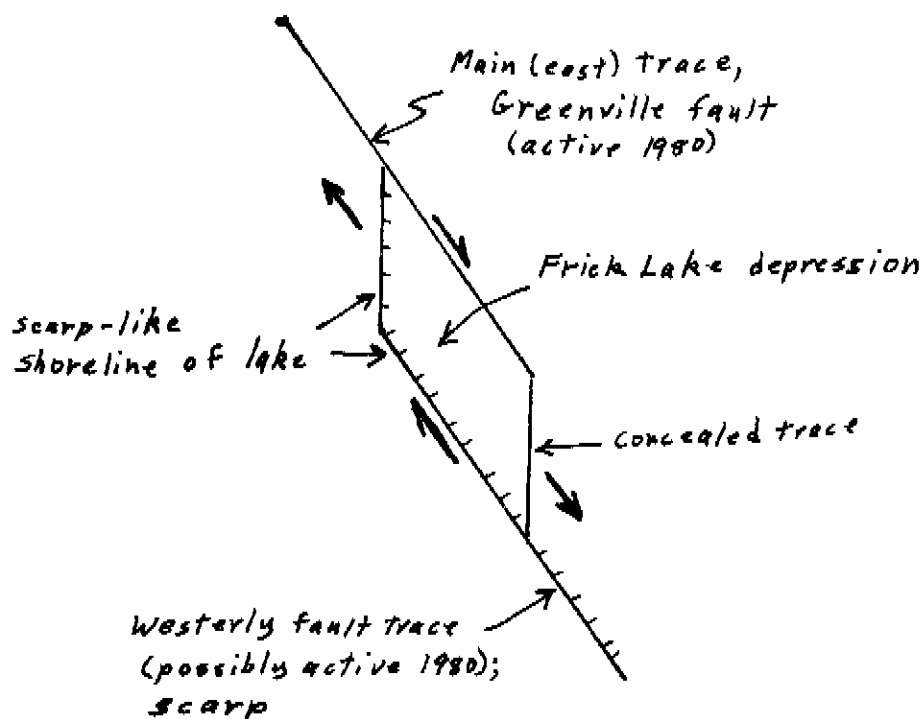
Figure 2. Model for extensional opening and basin formation resulting from right-lateral slip on right-stepping faults.

Laughlin Road south of Frick Lake. Frick Lake is a closed depression (sag pond) formed by recent subsidence, presumably caused by right lateral extension between two right-stepping faults (see diagram for model, Figure 2). The east (main) trace north of Frick Lake was known to be active after the earthquakes. The existence of an east-facing scarp bordering the west side of Frick Lake and the linear extension of that scarp to the south fits the model and is inferred to be the active extension of the Greenville fault south of Frick Lake. However, the only evidence of faulting south of Frick Lake was along the dirt road where 2 mm of right-lateral offset was noted along a small set of left-stepping cracks. Although this trace was not walked-out, no clear evidence of faulting could be identified to the south along Altamont Road.
